AHERA Asbestos Management Plan Update

Fern Ridge Middle School 88831 Territorial Highway Elmira, Oregon 97437

March 2023 Project No.: 52743.000

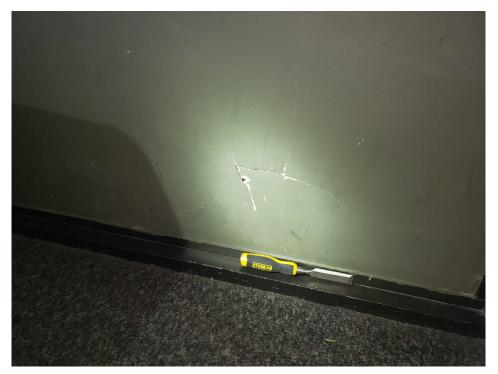
Photo 1. Cracked Cement Asbestos Board Panel at South Entry to Commons

Cement asbestos board was observed in the building. Before raising friability by sawing, drilling, etc., remove using wet methods and proper worker protection, modified isolation or full isolation depending upon application and quantity of material. A qualified project designer should determine appropriate method prior to abatement. Testing is not typically considered necessary since the inspector is usually able to visually identify the white asbestos fiber bundles bound into the cementitious matrix.

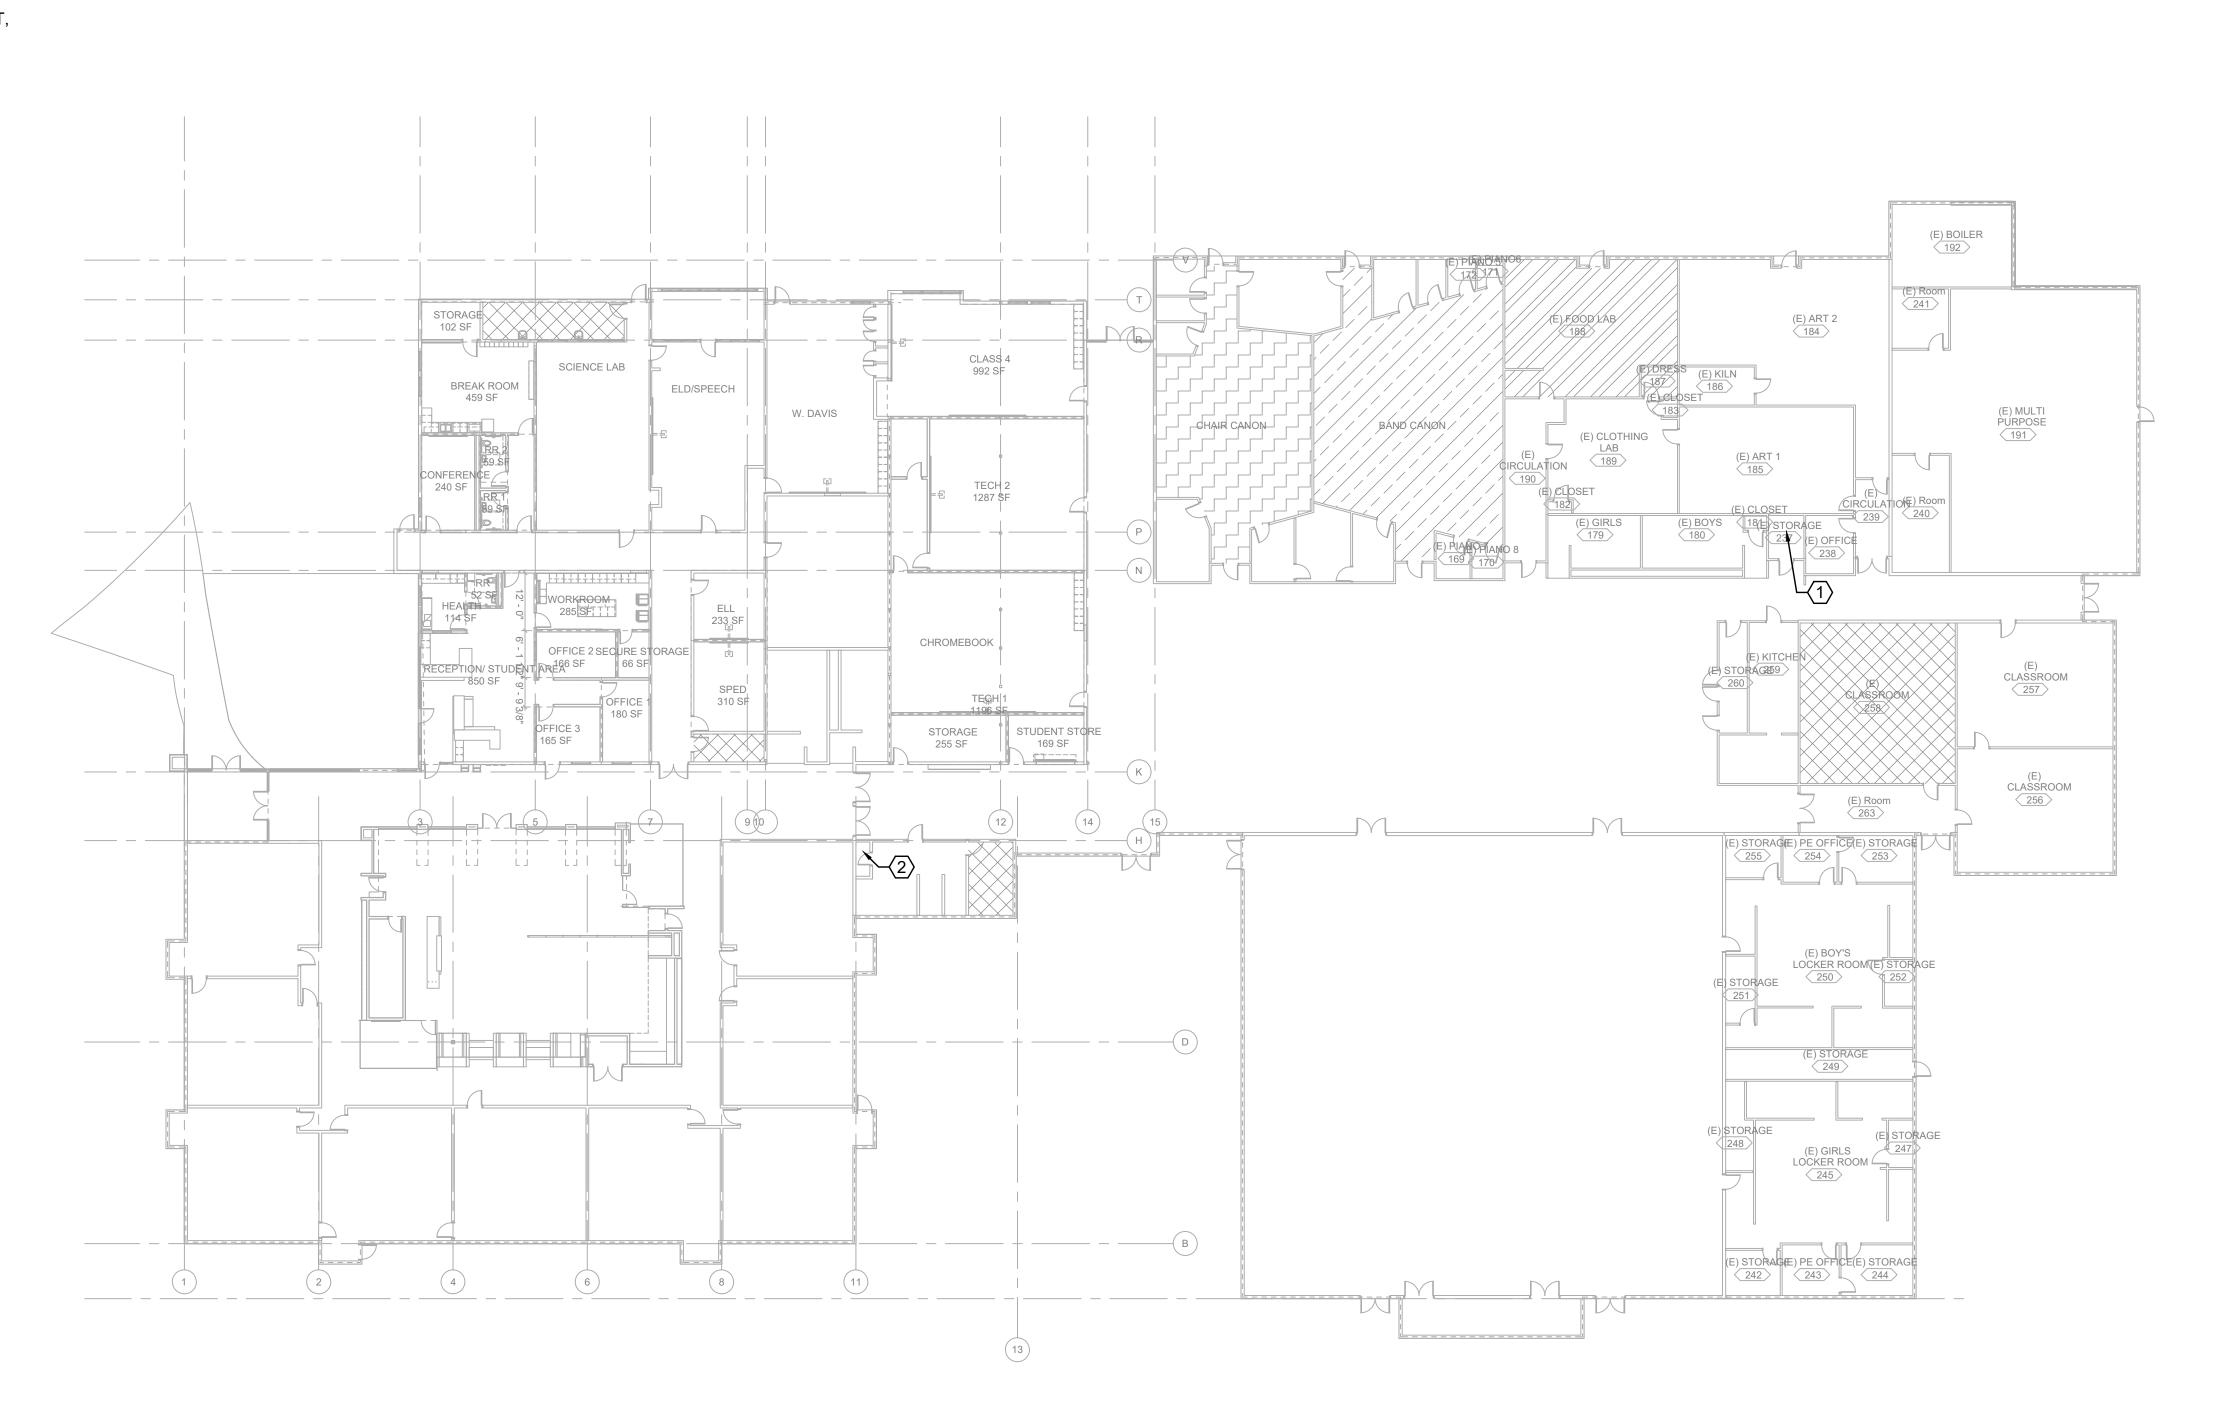
FIRST FLOOR - FLOORING MATERIALS

REMNANT ASBESTOS-CONTAINING FLOOR TILE MASTIC PRESENT UNDER CARPET TILES

ASBESTOS-CONTAINING SHEET FLOOR COVERING

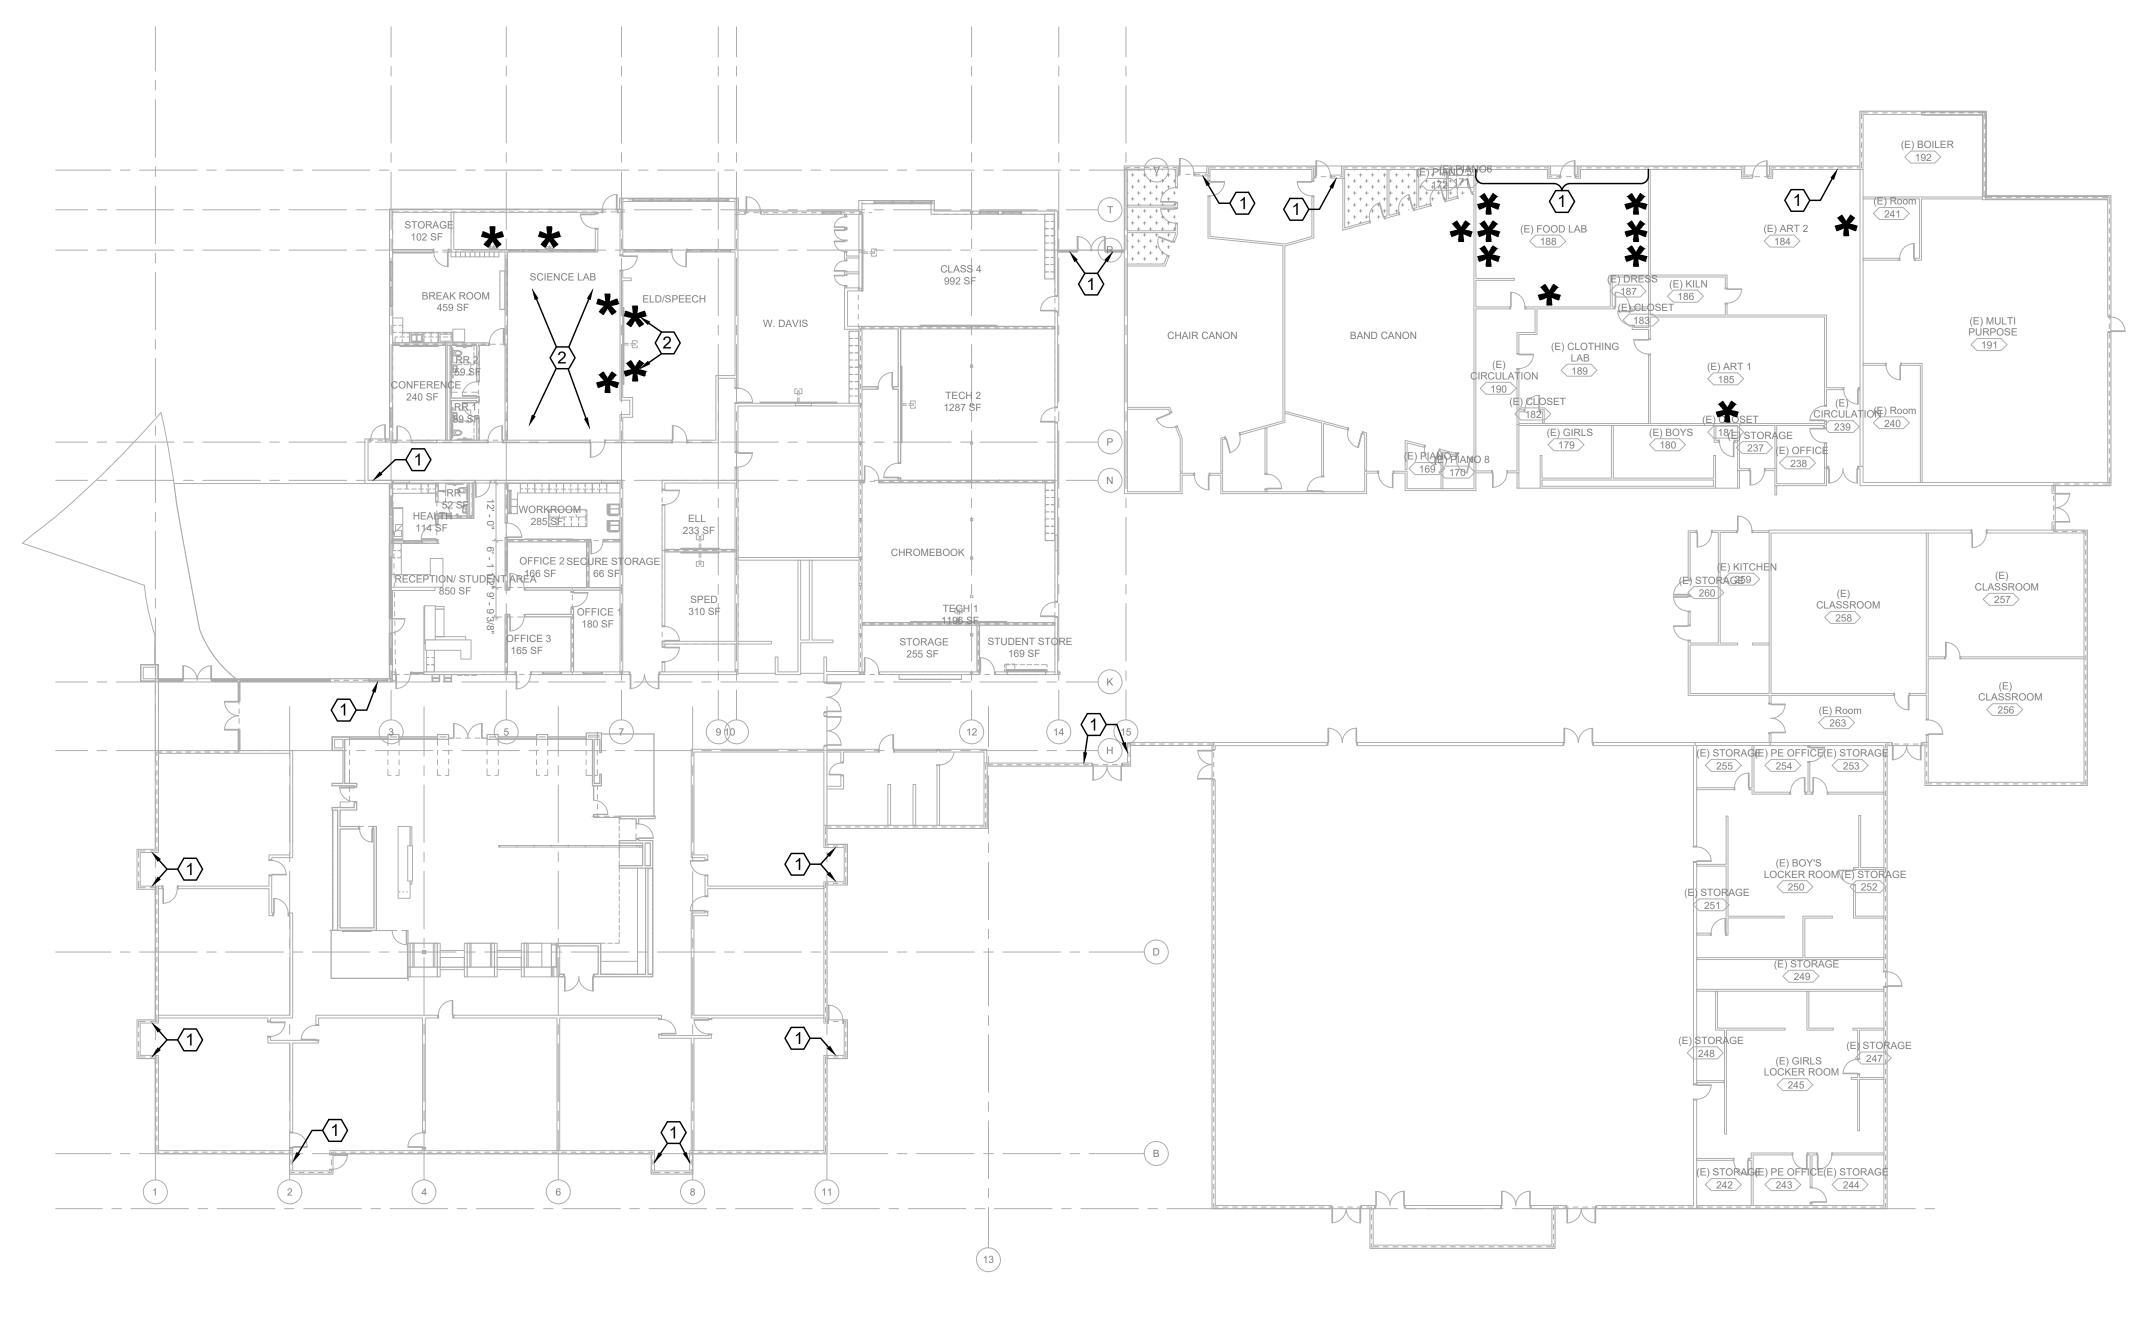
FIRST FLOOR - MISCELLANEOUS MATERIALS

CEMENT ASBESTOS PEGBOARD CEILING PANELS

ASBESTOS-CONTAINING SINK BASIN UNDERCOATING
